# PRO INSPECT

**Walk-through Inspection of:** 1234 Avenue, Gonubie, 5247

**For :** "Excited Estate Agent"

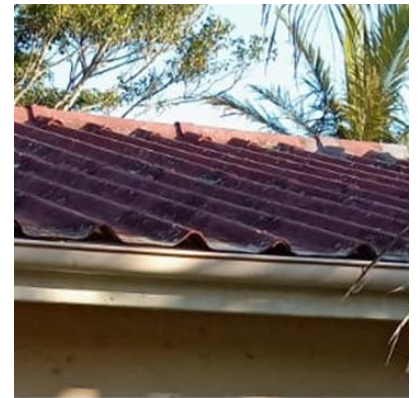
## Roof

Canadian pattern asbestos roof sheeting.  
Guttering is broken or absent around the roof.

The patio roof is rotten and covered in branches

The garage roof has Big 6 asbestos roof sheeting. The sheeting has holes and is broken in places.

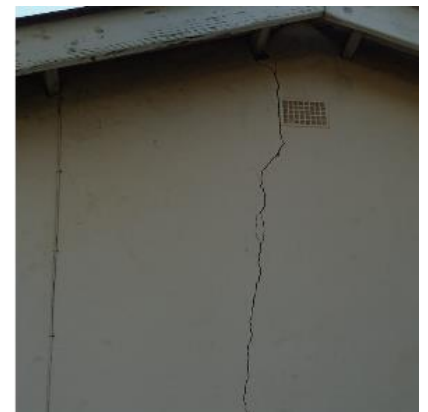
## Exterior walls

The outside walls have several cracks.

The east wall from the foundation to the pitch of the roof has a crack over 6mm wide. This serious structural issue has caused the entire house to shift from its centre.

Evidence is inside with the movement of the walls away from the ceiling in numerous places. On the west wall, there is evidence of water ingress causing damage to the masonry.

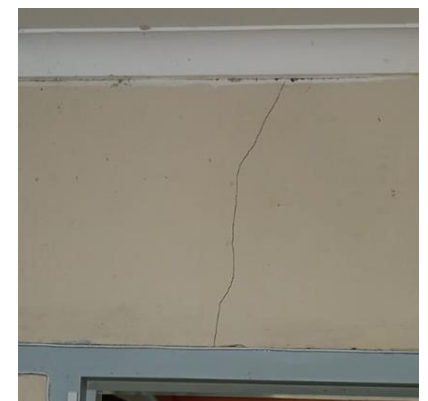
## Interior walls

Several cracks are visible along door frames and room entrances.  
The major crack on the east wall is visible on the inside as well.

This is a structural defect and needs immediate attention to prevent further structural damage.

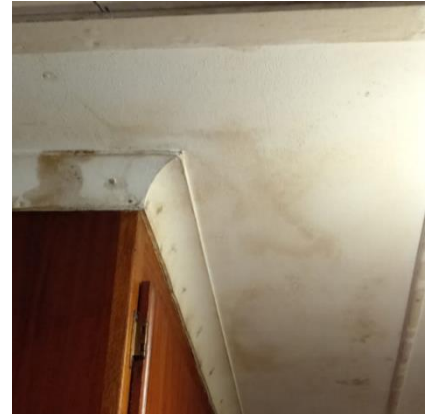
## Ceilings

The ceiling in the passage on the east side of the house has visible water staining. The cornices have been patched with tape.

This is caused by water intrusion from the roof. The inside of the ceiling was not part of this inspection.

Further inspection of the roof structure would be advised.

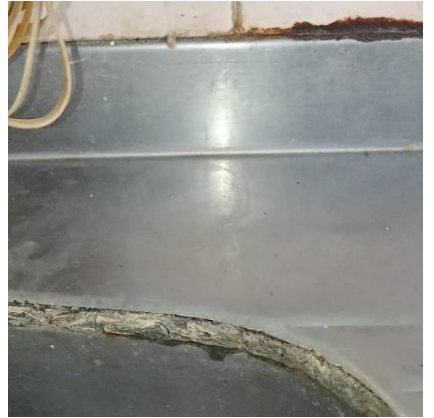
## Kitchen

The floor is tiled and walls around basin area.

Sink is a single basin type and is rusted and must be replaced.

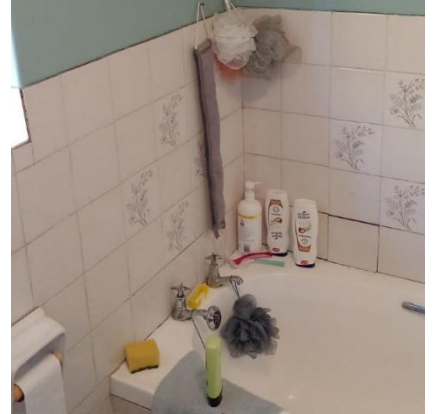
## Bathroom

Bath, basin, shower and toilet .

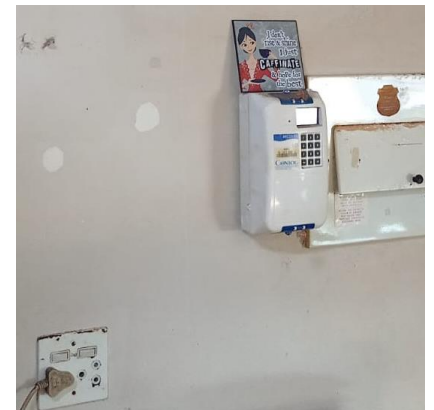
## Electrical

The plugs and light fittings and old metal type covers are extremely dirty.

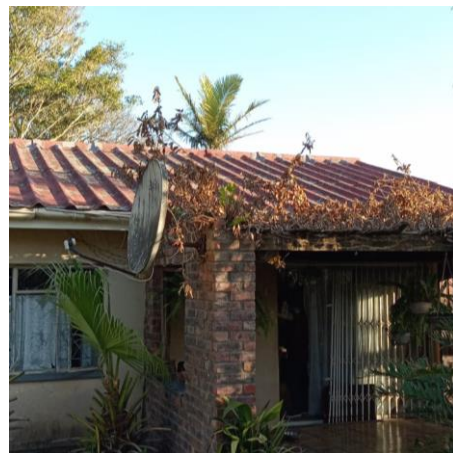
## Garden & vegetation

The erf is on level ground and stormwater could pose a problem as water flows against the foundation and walls of the house.

Gutter downpipes are not functional.

Some trees in the garden could be causing damage to the building structure. Advise that the vegetation be evaluated by a landscaping professional to alleviate these problems. Roots growing under or through the foundation need to be removed.

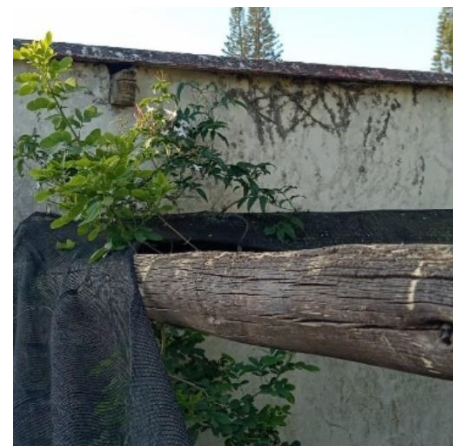
## Garage

Single garage attached to the main house. A carport structure has been built and attached to the front of the garage.

The walls of the garage are badly cracked. There is evidence of extreme water ingress and damage.

The garage roof is Big 6 asbestos is damaged. Trees are growing on the roof with roots penetrating the structure.

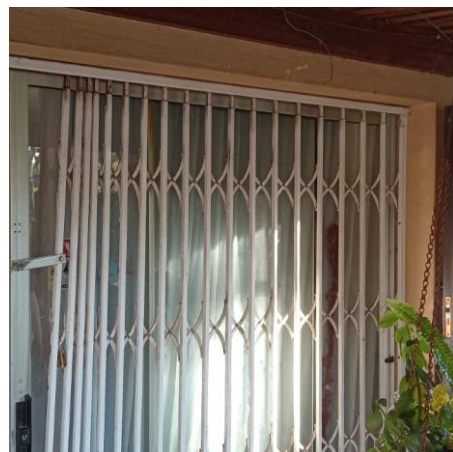
## Doors

Some wooden doors need some rejuvenation.

The security gate needs some servicing.

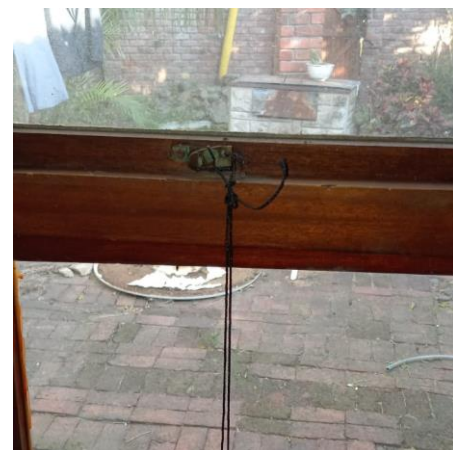
## Windows

Some windows lack handles an/or closing mechanisms. Window functionality was not checked.
