Confidential Inspection Report

INSPECTED ON Sunday, [REDACTED] at 09:00am

Inspector - Bazil Johnson Pro Inspect

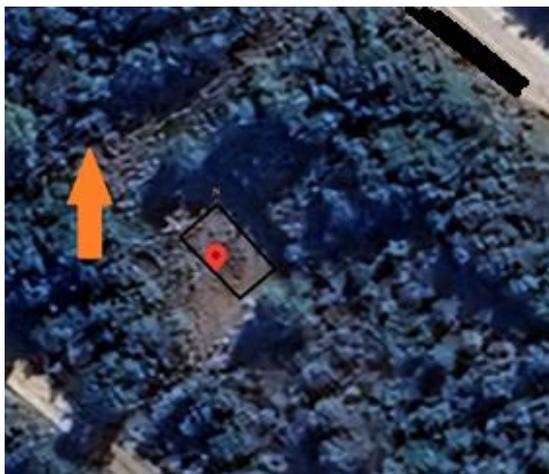
The building site has been excavated out against a hill. The soil is very shallow to a depth of less than 30 cm, and the embankment consists of shale rock which is very porous and results in stormwater runoff not being absorbed easily. The north side of building is less than 10 metres from embankment, and it would be recommended that a suitable stormwater retaining wall and/or French drain be built to divert any water that may flow from the service road to the north of the construction. In the event of torrential rain, the possibility of stormwater reaching the foundation structure is likely.

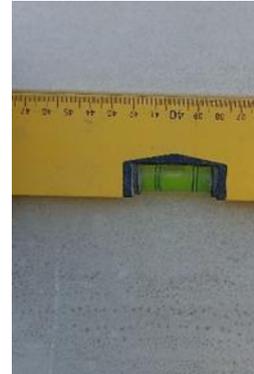
Level of planks

1. The planks are not installed parallel. As a result of the walls not being perpendicular this has added extra distortion in the application of the planks. This should have been corrected on the face of the wall as the corner coverings would be able to hide any blemishes. As the planks have been install flush to a non-perpendicular corner, this has resulted in several planks not being installed parallel to each other. The negative result of this installation is accumulative:
 - 1.1 mounting screws are not installed in a pattern.
 - 1.2 The gap between each plank is not equal. etc.
 - 1.3 The planks are not installed flush horizontally against the other planks.

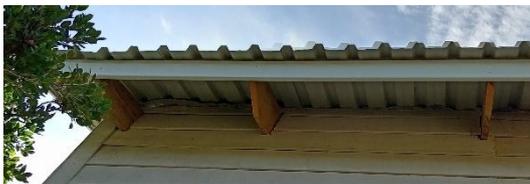
2. The cladding below the roof sheets and above the trusses have been poorly installed and display shocking workmanship. The planks have been broken when installed at the cutouts for the trusses. These planks appear to have been forced into position with total disregard for adhering to the manufacturer's recommendations for proper installation, i.e. that they should lie flush onto each other to make a proper overlap.

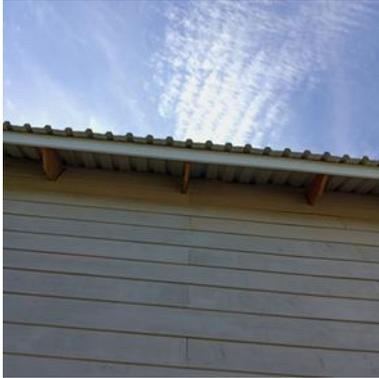
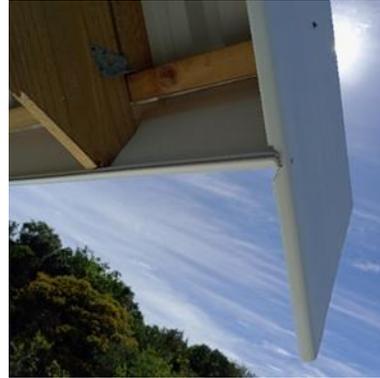
1. Installation of trusses and roof beams are not 100% vertically aligned on the walls. This has resulted in the other wooden roof components not lying level on the trusses. There are several hurricane clamps not nailed flush against the trusses to attach the purlins. Incorrect fastening of components can compromise the roof structure in a coastal home prone to high winds.

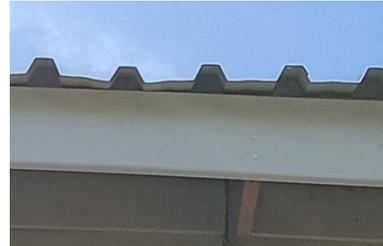
2. The roof sheeting has not been installed properly on the western side. From the ground it was observed that the sheets have been forced together. This has resulted in the sheet being convex shaped instead of lying level on the purlins. This needs to be repaired.

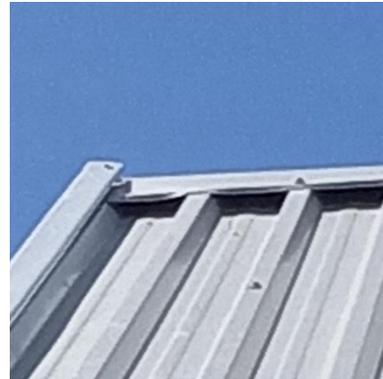
3. The ridge flashing on the main double storey building has been bent or buckled during installation and may compromise the effectiveness of the waterproofing of the roof structure. This is a result of poor workmanship.

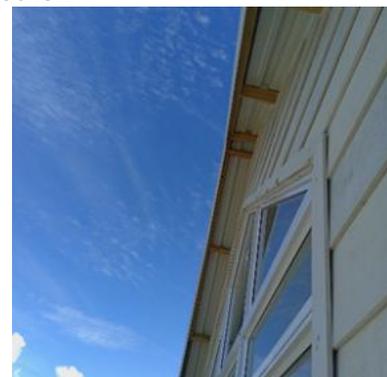
4. Viewed from the ground, it can clearly be seen how the walls have **not** been constructed plumb. The roof sheets are not lying perpendicular to the rake side of the roof. An estimated difference of at least 80mm is apparent from one side to the other.

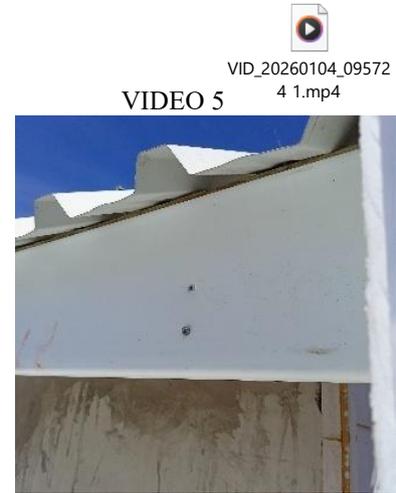
5. The PVC fascia boards have been installed directly onto the roof trusses. As the PVC is a very soft material, proper mounting is required and the screws must be installed properly to prevent movement. Direct installation has resulted in the fascia board looking wavy because of more that 600mm spaces between attachment screws. It is recommended that a suitable backing board be installed onto the trusses and the PVC board attached to the board to prevent warping.

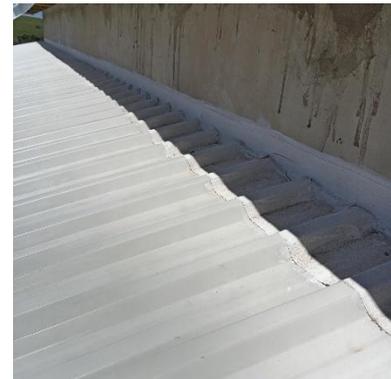
6. The flashing of the lower roof where it meets the main cement wall is deficient. When a roof meets a parapet type wall it is recommended that proper metal flashing be installed into the cement wall with the necessary drip flashing to prevent any water penetration.

Installation of a waterproof membrane does not provide really effective sealing if not done properly as is the case with this installation. This membrane should be installed without any creases or air pockets. This is an installation defect and not recommended.

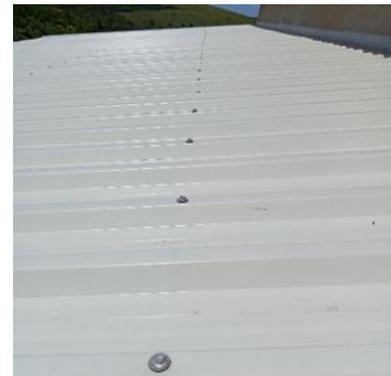
7. There are some roof screws that have been over fastened. They do, however, do not seem to have resulted in any damage to the roof sheeting in a negative way.

Unfortunately, for the perfectionist the roof screws are not all installed in a straight line.

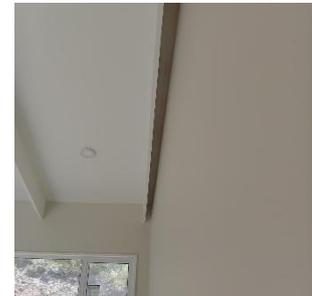
3. The rafters in the ceiling have a distance differentiation of at least 6 cm from the west to the east side of the ceiling against the internal wall. Reason is either: non perpendicular wall construction or a rafter that has been installed incorrectly. The 42mm discrepancy measured between the walls is the more plausible reason.

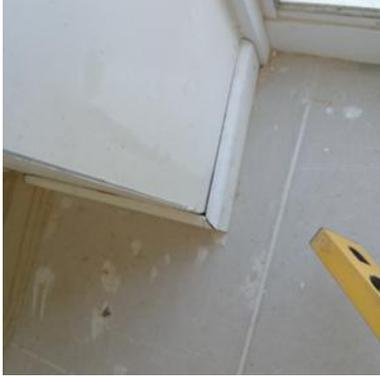
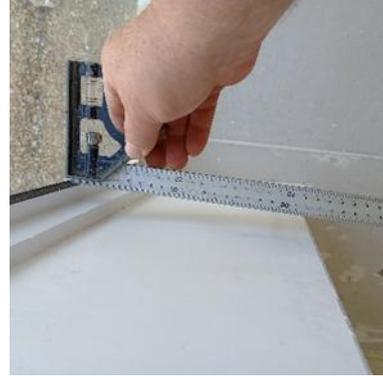
6. The vertical pillar that has been built at the foot of the staircase and the back door is not square and is aesthetically displeasing and easily noticeable when viewed directly from the opposite doorway.

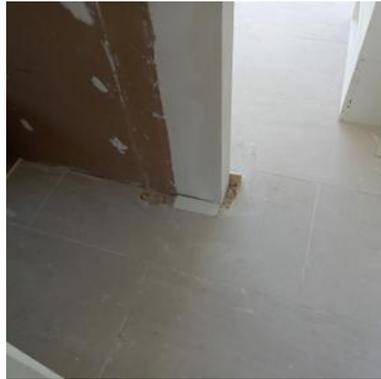
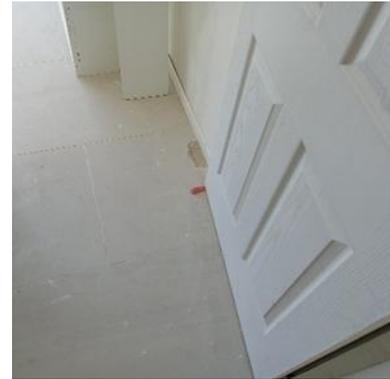
1. There are two places close to the main bedroom and bathroom that the tiles have been cut out with a grinder to install a door incorrectly. These tiles need to be replaced as they will not be repairable without compromising the aesthetics of the building.

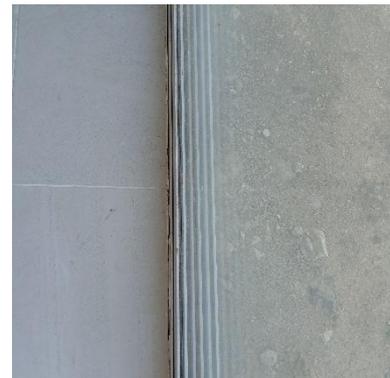
2. Skirting boards have not yet been installed. However, there are places where the tiles are meeting the frames of the door where the grouting is already showing signs of cracking.

This is a problem and is possibly related to the force that needs to be applied to the doors when closing. The doors need to be realigned properly before this can be repaired.

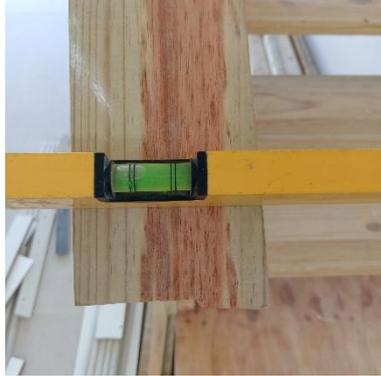
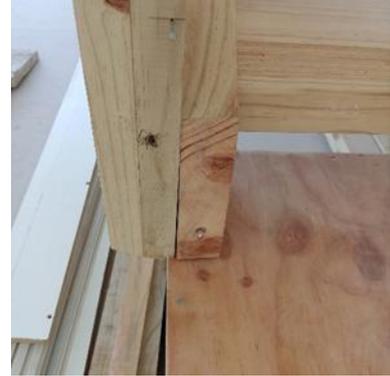
1. The wood used for the handrail and balustrade are more suitable for an outside deck area. The hand railing on the stairs is warped and not installed level to the ground.
2. The pillars attaching the balustrades are dangerous. They should be bolted and not attached with 3 Tek screws. The bottom pillar has movement of about 10cm in either direction from the wall when pushed.

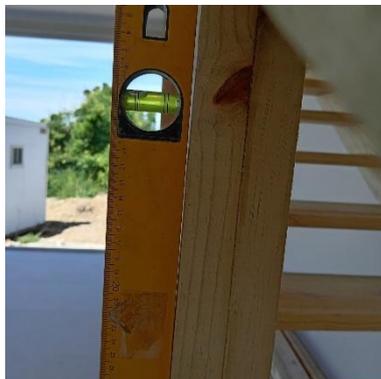
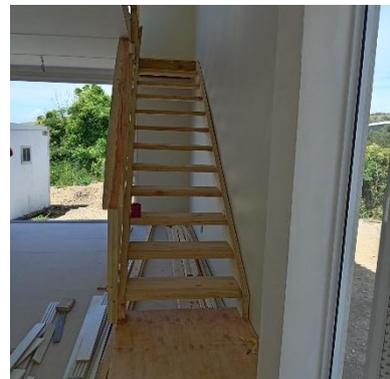
3. Pillars are not vertically installed.
4. There is a bottom landing at the bottom of the steps that is a bit problematic. If it is still going to get a step installed it will be a trip hazard as it will block the door walkway. Without a step, anyone wanting to climb the steps will have to climb at least 40cm to get onto the first landing.

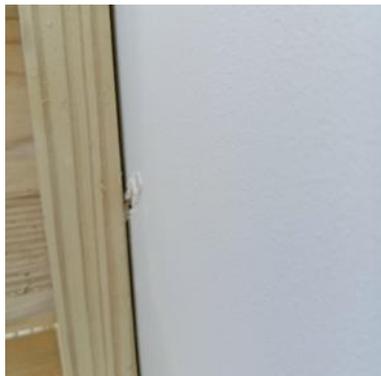
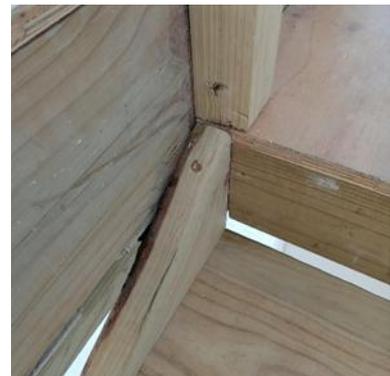
5. The stairs are not fitting flush against the wall as a result of either warped wood or skew walls.

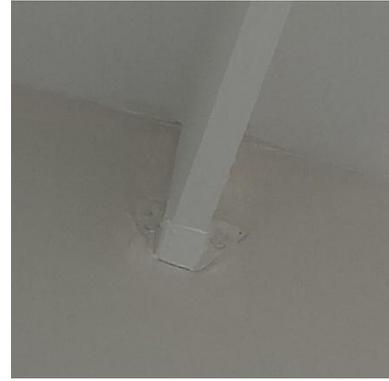
1. The rafters in the main bedroom that are attached with hanging clamps have not been installed vertically and a few are lying at an angle. Recommend that this be remediated before painting.
2. The rafters in the high ceiling do appear to be installed correctly, however the ridge rafter installed in the pitch of the roof is not installed level on both end of the ceiling. It appears that this is warped. Being painted white accentuates this irregularity. Recommend that it be evaluated and repaired.

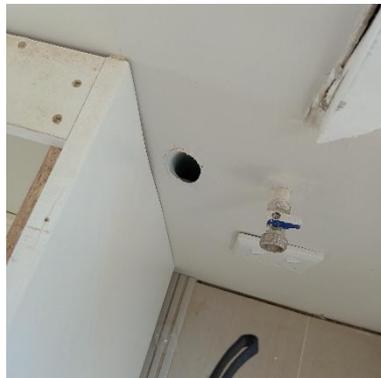
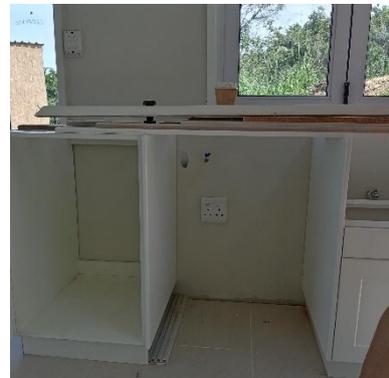
1. In the kitchen cupboards there are two plugs installed below water outlets. This is hazardous as any electrical outlet should not be installed below a water outlet. Recommend that this be remediated as it can be a code violation.

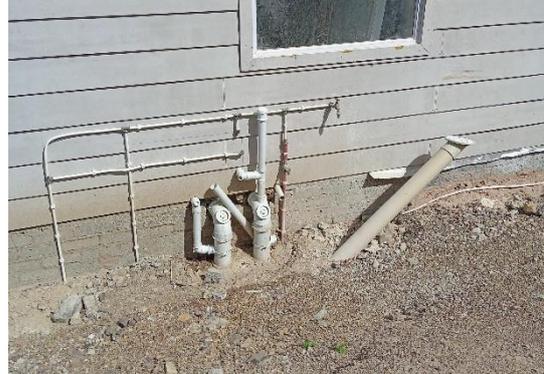
1. The waste pipes that have been installed in the walls for the shower and basin are 32mm. However, as the pipes exit the wall outside, they are connected to a 50mm PVC outlet pipe. It is always recommended that a 50mm pipe be installed in a shower for quick water runoff
2. It is never a good idea connecting water waste pipes from showers directly to the sewer line due to odour reflux from sewerage. No P-trap is installed on the shower drainpipe. This is an important connection.
